# TEST REPORT

Cable Gland

AG-25

**TEST REPORT****IEC60529****Degrees of protection provided by enclosure(IP code)**

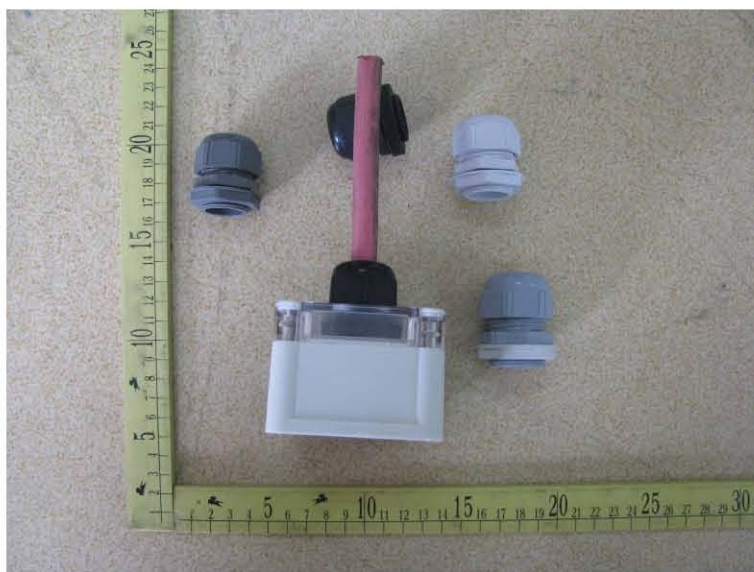
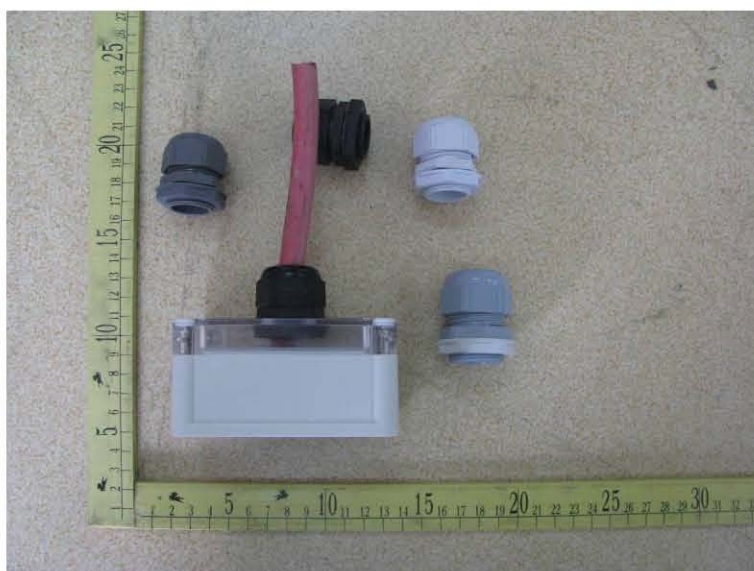
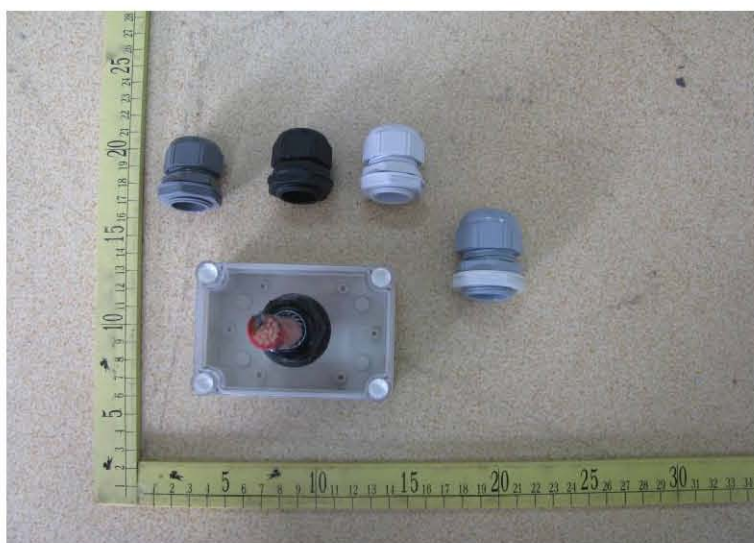
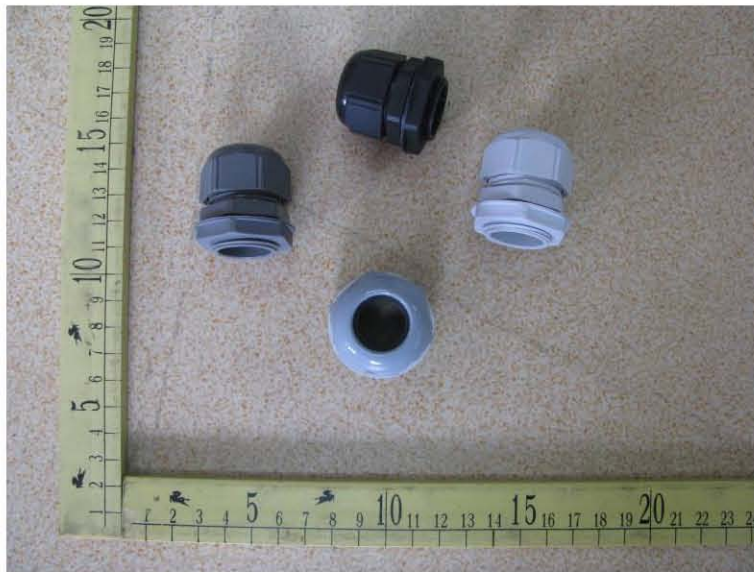
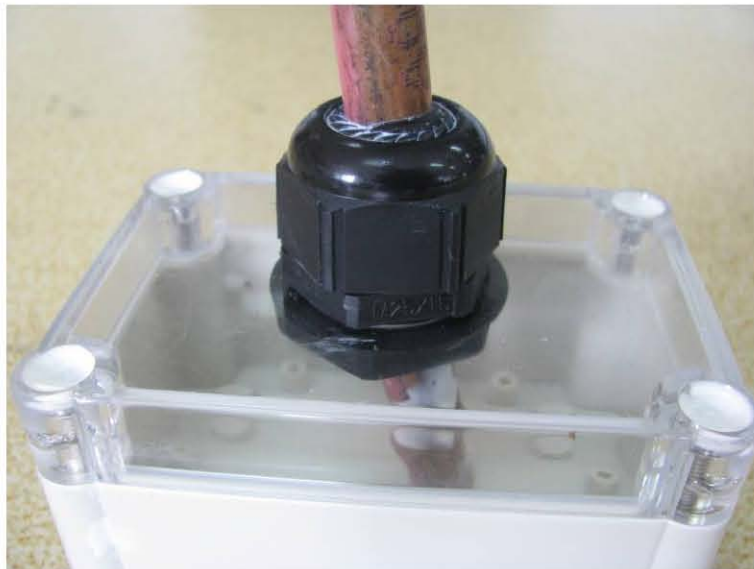
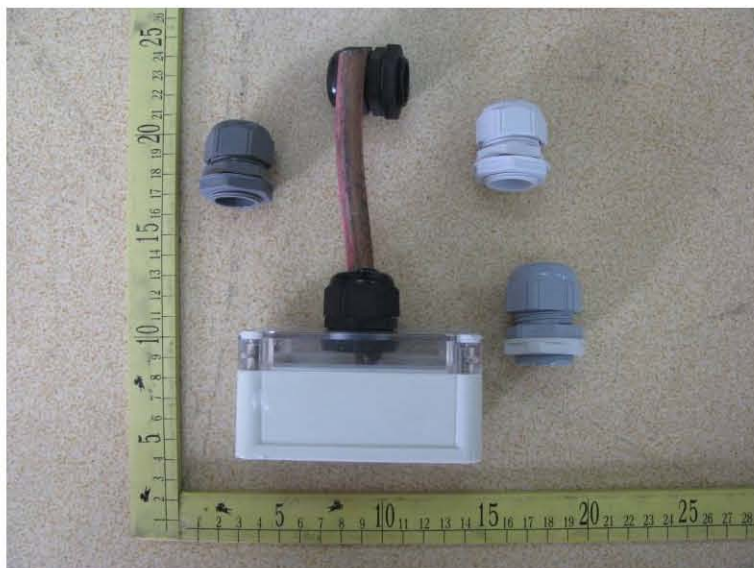
## Appliance Photos:

Sample Name: Cable Gland

Model/Type reference: AG-25

Ratings: M25\*1.5, IP68

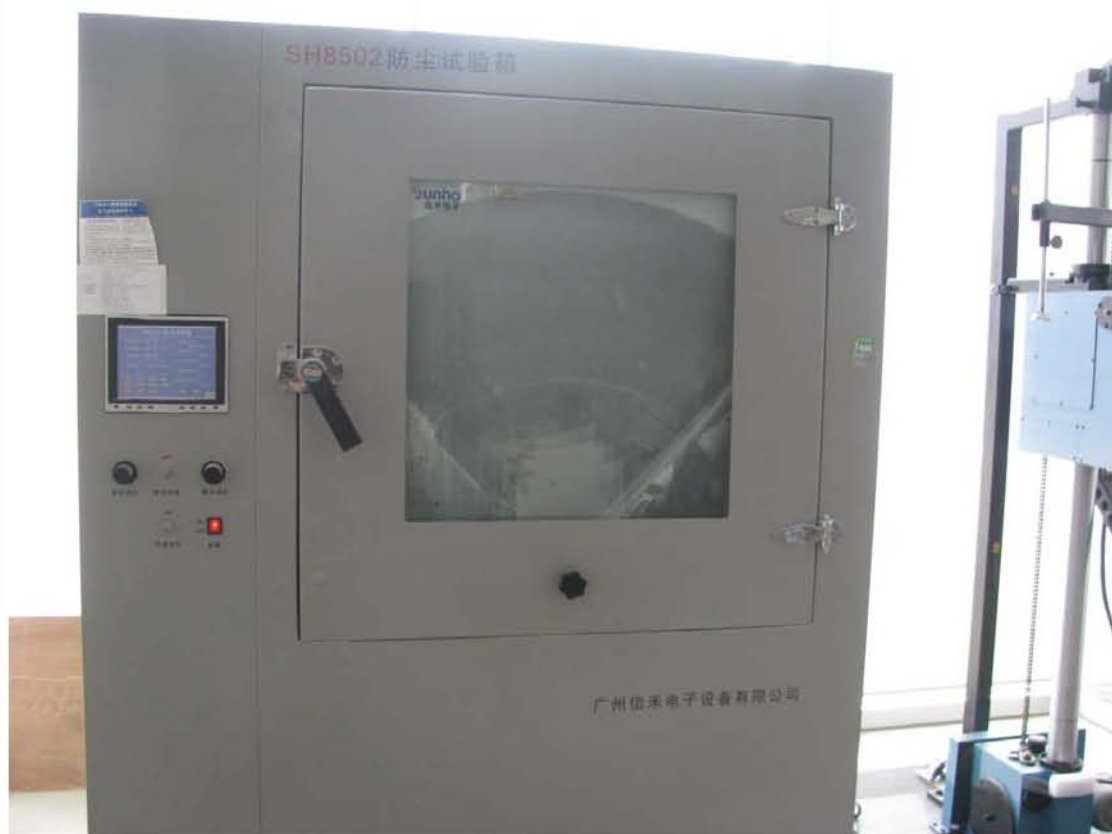
Photograph:

IP6X: The object is freely suspended in the dust chamber, lasted 8 hours with the depression not exceed 2KPa, the pressure inside the enclosure is maintained below the surrounding atmospheric pressure by a vaccum pump.

IP6X: No deposit of dust is observable inside the sample at the end of the test. So the protection is satisfactory.

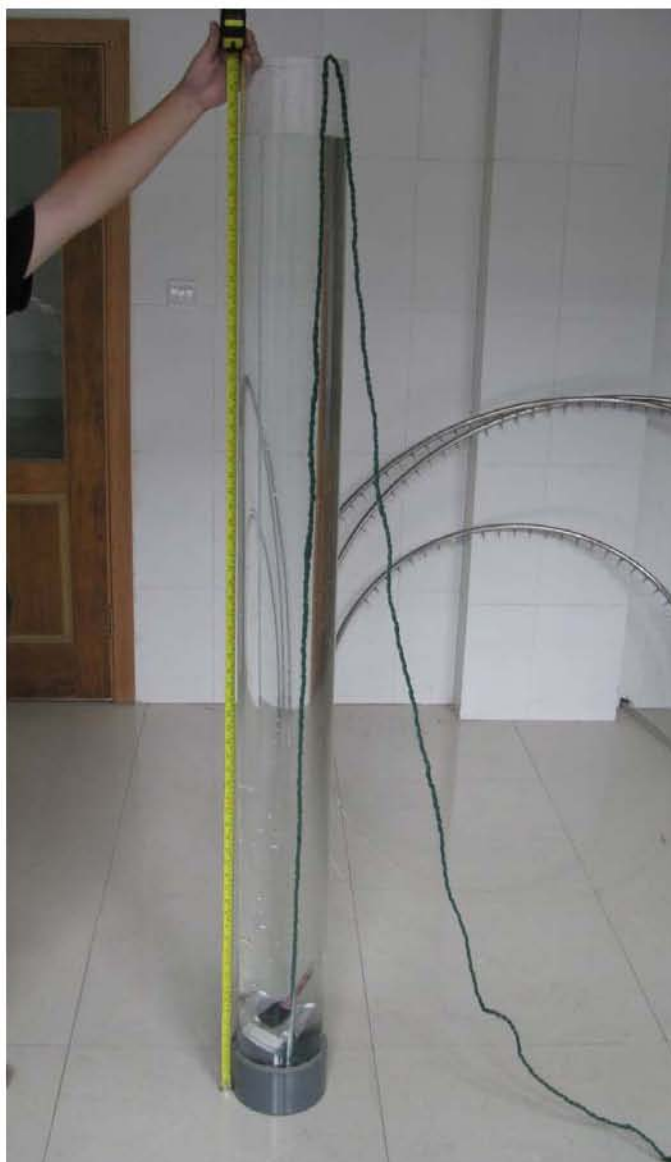
Operating conditions: IPX8: The lowest point of enclosures is located 1.5m below the surface of the water, the duration of the test is 35min; the water temperature does not differ from that of the equipment by more than 5K.

Phenomenon( after the test): IPX8: No water entered.

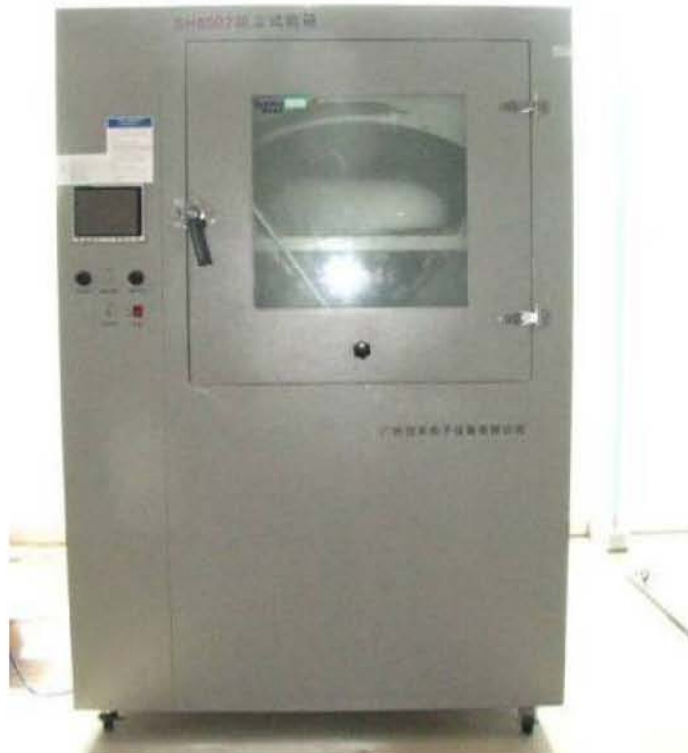
Fig.1 Dust chamber

1. Test equipments: Dust chamber (see Fig. 1), Immersiom test device(see Fig. 2),
2. Temperature: 22.5℃ Humidity: 70%RH
